**Flood Control Project Maintenance
Levee Inspections**

Maintenance Issue Types Only, Levee Inspection Report By Mile - Fall 2014

Reclamation District No. 2101 Blewett

Waterway	Bank	Unit Miles	Inspection Start/End	Inspector
Unit No. 01 San Joaquin River	Left	3.16	10/28/2014 10/28/2014	Maksim Khashchuk

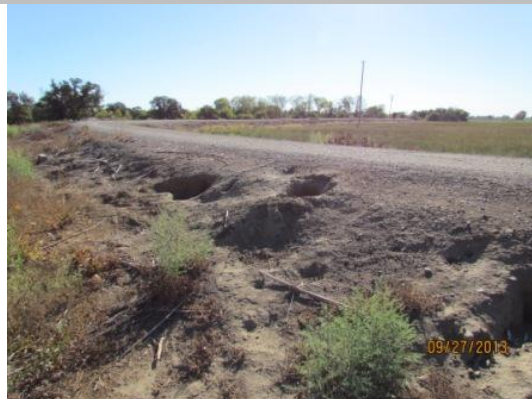
Photo 1 of 1 : FA_2014_RD2101_326_12_20141001_00005.jpg

LM Start	0.04	Rating **	M	Issue No.	12
LM End	0.04	Issue Type +	Ma	Location *	WS
Category	Earthen Levee			GPS Latitude/Longitude	
				Start	End
Item	Animal Control			37.657648 °	37.657648 °
				-121.253812 °	-121.253812 °
DWR ID	DWR_RD2101_01_s_2012_12				
Action/Comments					
No rodents visible, but rodent burrows visible; need to backfill and compact or grout burrows.

View of rodent holes on waterward slope, facing upstream.

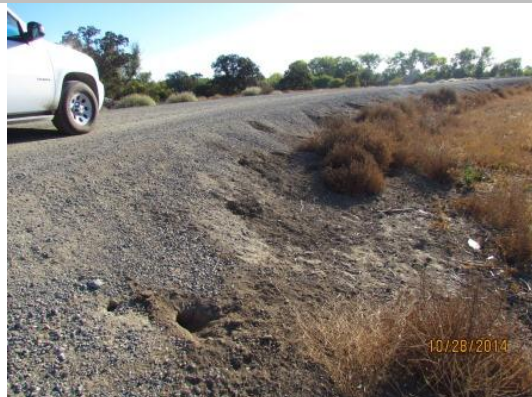
Photo 1 of 1 : FA_2014_RD2101_326_16_20141029_00031.jpg

LM Start	0.07	Rating **	M	Issue No.	16
LM End	0.07	Issue Type +	Ma	Location *	LS
Category	Earthen Levee			GPS Latitude/Longitude	
				Start	End
Item	Animal Control			37.657811 °	37.657811 °
				-121.253269 °	-121.253269 °
DWR ID	DWR_RD2101_01_s_2013_16				
Action/Comments					
No rodents visible, but rodent burrows visible; need to backfill and compact or grout burrows.					
Inspector Comments: Continue rodent extermination and backfilling the rodent burrows.

View of rodent burrows on the landside levee slope.

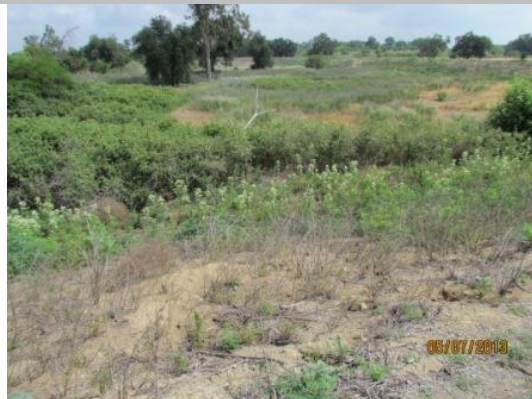
Photo 1 of 1 : FA_2014_RD2101_326_26_20141001_00015.jpg

LM Start	0.70	Rating **	U	Issue No.	26
LM End	0.70	Issue Type +	Ma	Location *	WS
Category	Earthen Levee			GPS Latitude/Longitude	
				Start	End
Item	Animal Control			37.659907 °	37.659907 °
				-121.244219 °	-121.244219 °
DWR ID	DWR_RD2101_01_s_2013_26				
Action/Comments					
Exterminate rodents and backfill and compact or grout burrows.

View of the rodent burrows on the waterside levee slope.

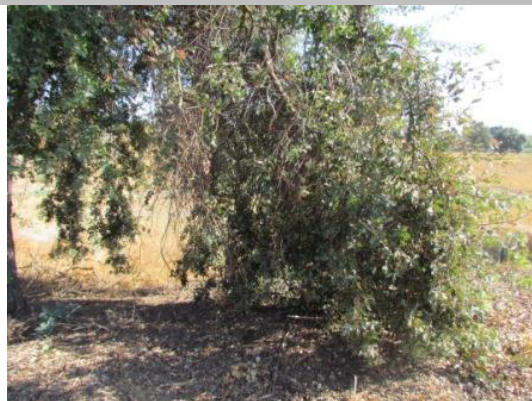
Photo 1 of 1 : FA_2014_RD2101_326_11_20141001_00004.jpg

LM Start	0.75	Rating **	M	Issue No.	11
LM End	0.75	Issue Type +	Ma	Location *	WS
Category	Earthen Levee			GPS Latitude/Longitude	
				Start	End
Item	Trim / Thin Trees			37.659705 °	37.659705 °
				-121.243306 °	-121.243306 °
DWR ID	DWR_RD2101_01_f_2012_11				
Action/Comments					
Trim trees to at least five feet above ground level.					
Inspector Comments: Trim tree to allow access and visibility.

View of tree branches obstructing waterside slope.

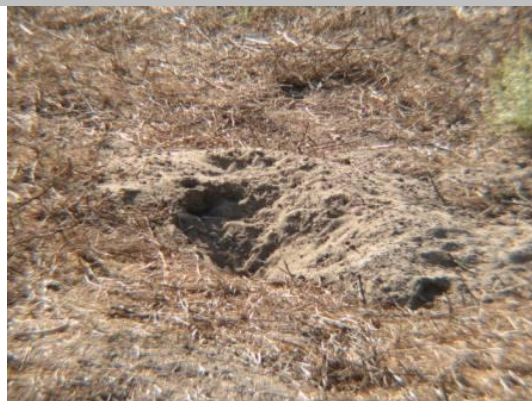
Photo 1 of 1 : FA_2014_RD2101_326_3_20141001_00002.jpg

LM Start	0.88	Rating **	M	Issue No.	3
LM End	0.88	Issue Type +	Ma	Location *	LS
Category	Earthen Levee			GPS Latitude/Longitude	
				Start	End
Item	Animal Control			37.658663 °	37.658663 °
				-121.241750 °	-121.241750 °
DWR ID	DWR_RD2101_01_s_2012_3				
Action/Comments					
No rodents visible, but rodent burrows visible; need to backfill and compact or grout burrows.

11/02/2011 Active rodent burrow.

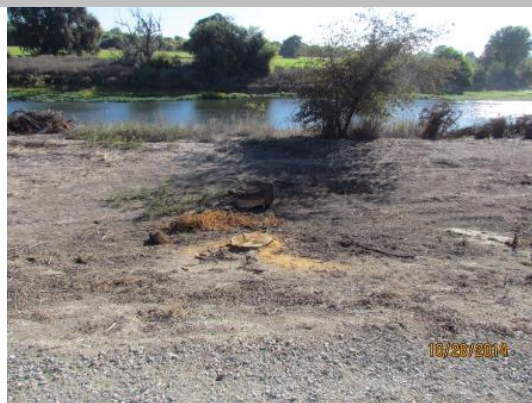
Photo 1 of 1 : FA_2014_RD2101_326_33_20141029_00033.jpg

LM Start	1.03	Rating **	N	Issue No.	33
LM End	1.03	Issue Type +	Ma	Location *	WS
Category	Earthen Levee			GPS Latitude/Longitude	
				Start	End
Item	Trim / Thin Trees			37.656745 °	37.656745 °
				-121.241104 °	-121.241104 °
DWR ID	DWR_RD2101_01_f_2014_33				
Action/Comments					
Tree stumps.

View of the tree stump at the waterside levee toe.

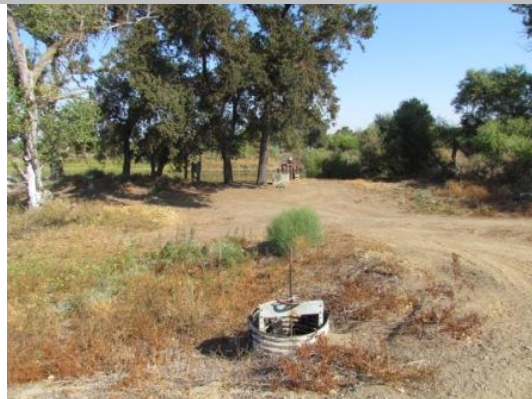
Photo 1 of 1 : FA_2014_RD2101_326_13_20141001_00006.jpg

LM Start	1.62	Rating **	A/W	Issue No.	13
LM End	1.62	Issue Type +	Ma	Location *	WS
Category	Earthen Levee			GPS Latitude/Longitude	
				Start	End
Item	Encroachments			37.651555 °	37.651555 °
				-121.234319 °	-121.234319 °
DWR ID	DWR_RD2101_01_s_2012_13				
Action/Comments					
Pipe					
Inspector Comments: Pipe penetrates through levee. Closure valve on water side slope.

Photo of pump in background and CMP riser with valve in foreground.

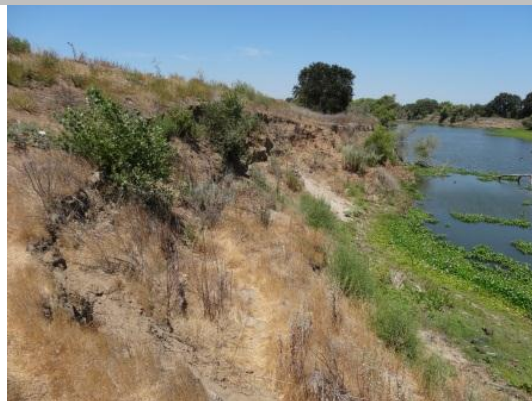
Photo 1 of 1 : SJR2014_RD2101U01RM73.92_1.jpg

LM Start	1.91	Rating **	U	Issue No.	1
LM End	2.00	Issue Type +	Ma	Location *	WS
Category	Supplemental			GPS Latitude/Longitude	
				Start	End
Item	DWR Erosion Survey			37.650259 °	37.650259 °
				-121.228961 °	-121.228961 °
DWR ID					
Action/Comments					
Inspector Comments: 07/17/2014: No significant change observed. 09/20/2013: Site has been visited. There are signs of further erosion development along the levee slope and toe. 07/18/2012: The erosion has further developed toward levee crown. Vegetation has been removed. 08/18/2011: The erosion progressed significantly during the past flood season. The levee toe along the erosion site was washed away, and the erosion has cut the levee structure up to the point about 1/3 of the levee slope. The scarp height is approximately 17 feet. Very dense vegetation and trees are visible. 10/19/2010: No significant change observed on site. Remaining levee berm topsoil is of silty sand mixture. The erosion is near the downstream transition. An eddy has formed, and has scoured away a 100-foot section of the bank, possibly encroaching into the levee prism. Vegetation on site includes willows, oak, and cotton wood located from the bench to the toe. On the landside are rows of corn crop. 08/05/2010: Recommended for Repair, per CLRO. 2009: Site recommended as annual assessment and monitoring if critical erosion site, per CLRO CES Evaluation 2008 Report; an eddy has formed, eroding bank and intruding into the levee prism; Site # is the same as RM76.3, LM1.89; previously rated "U". 08/30/2007: Recommended for short list of immediate repair sites; silty sand levee material. [2014 Site ID:RD2101U01RM73.92]

Upstream view of the erosion.

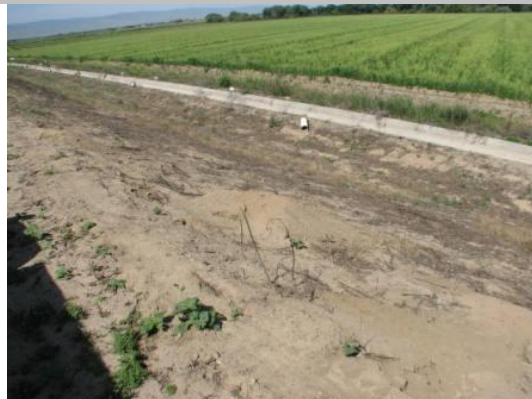
Photo 1 of 1 : FA_2014_RD2101_326_30_20141001_00023.jpg

LM Start	2.39	Rating **	M	Issue No.	30
LM End	2.39	Issue Type +	Ma	Location *	LS
Category	Earthen Levee			GPS Latitude/Longitude	
				Start	End
Item	Animal Control			37.645785 °	37.645785 °
				-121.226337 °	-121.226337 °
DWR ID	DWR_RD2101_01_s_2012_30				
Action/Comments					
Exterminate rodents and backfill and compact or grout burrows.

View of levee material removed by rodent activity on landside slope, facing upstream. 05/02/2012

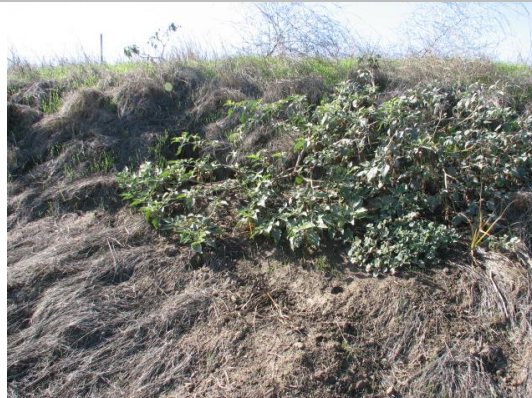
Photo 1 of 1 : FA_2014_RD2101_326_27_20141001_00016.jpg

LM Start	2.88	Rating **	U	Issue No.	27
LM End	2.88	Issue Type +	Ma	Location *	WS
Category	Earthen Levee			GPS Latitude/Longitude	
				Start	End
Item	Animal Control			37.640305 °	37.640305 °
				-121.230095 °	-121.230095 °
DWR ID	DWR_RD2101_01_s_2012_27				
Action/Comments					
No rodents visible, but rodent burrows visible; need to backfill and compact or grout burrows.					
Inspector Comments: Active burrows with squirrels observed. Burrows on both sides of levee.

Rodent holes on levee slope hidden by vegetation.

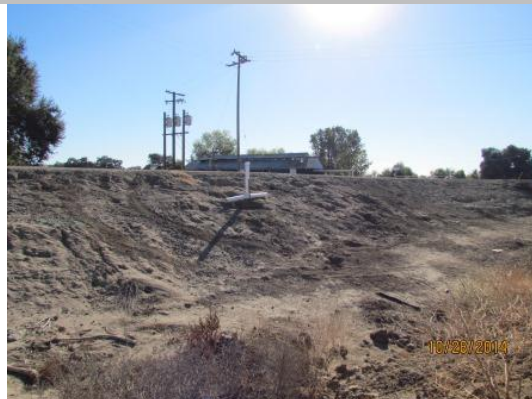
Photo 1 of 1 : FA_2014_RD2101_326_28_20141029_00032.jpg

LM Start	2.89	Rating **	U	Issue No.	28
LM End	2.89	Issue Type +	Ma	Location *	LS
Category	Earthen Levee			GPS Latitude/Longitude	
				Start	End
Item	Animal Control			37.640134 °	37.640134 °
				-121.230019 °	-121.230019 °
DWR ID	DWR_RD2101_01_s_2012_28				
Action/Comments					
No rodents visible, but rodent burrows visible; need to backfill and compact or grout burrows.					
Inspector Comments: Numerous rodent holes throughout levee slope.

View of numerous rodent holes with bait stations present.

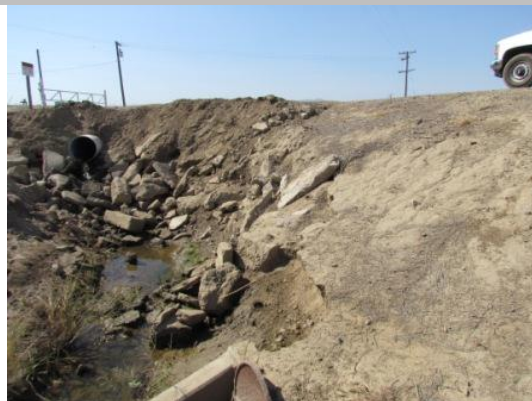
Photo 1 of 2 : FA_2014_RD2101_326_29_20141001_00021.jpg

LM Start	2.91	Rating **	M	Issue No.	29
LM End	2.91	Issue Type +	Ma	Location *	WS
Category	Earthen Levee			GPS Latitude/Longitude	
				Start	End
Item	Erosion / Bank Caving			37.639852 °	37.639852 °
				-121.229980 °	-121.229980 °
DWR ID	DWR_RD2101_01_s_2012_29				
Action/Comments					
Schedule repair of erosion site prior to the next inspection.

View of repaired site, but it appears that erosion is still occurring.
09/25/2012

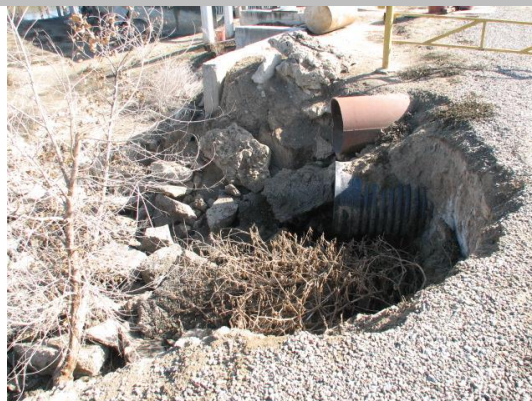
Photo 2 of 2 : FA_2014_RD2101_326_29_20141001_00022.jpg

Levee slope is being eroded at this location. Repair needed to preserve access road.

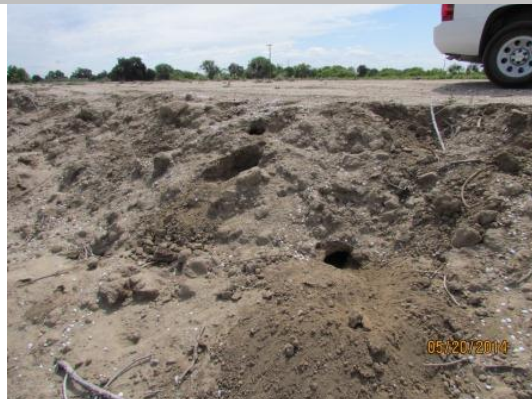
Photo 1 of 1 : FA_2014_RD2101_326_17_20141001_00009.jpg

LM Start	3.02	Rating **	M	Issue No.	17
LM End	3.20	Issue Type +	Ma	Location *	LS
Category	Earthen Levee			GPS Latitude/Longitude	
				Start	End
Item	Animal Control			37.638760 °	37.638760 °
				-121.231341 °	-121.231341 °
DWR ID	DWR_RD2101_01_s_2012_17				
Action/Comments					
Exterminate rodents and backfill and compact or grout burrows. Inspector Comments: Active burrows with rodents present.

Numerous burrows present, some already caving in, others are active.

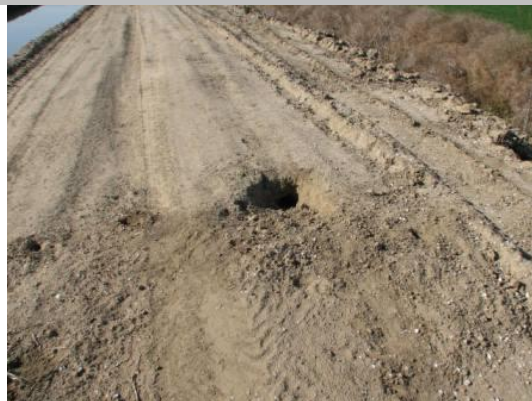
Photo 1 of 3 : FA_2014_RD2101_326_18_20141001_00010.jpg

LM Start	3.11	Rating **	M	Issue No.	18
LM End	3.11	Issue Type +	Ma	Location *	CR
Category	Earthen Levee			GPS Latitude/Longitude	
				Start	End
Item	Animal Control			37.637943 °	37.637943 °
				-121.232620 °	-121.232620 °
DWR ID	DWR_RD2101_01_s_2012_18				
Action/Comments					
No rodents visible, but rodent burrows visible; need to backfill and compact or grout burrows.					
Inspector Comments: Large burrow in crown with no rodents present at time of inspection.

11/02/2011 Large burrow in crown.

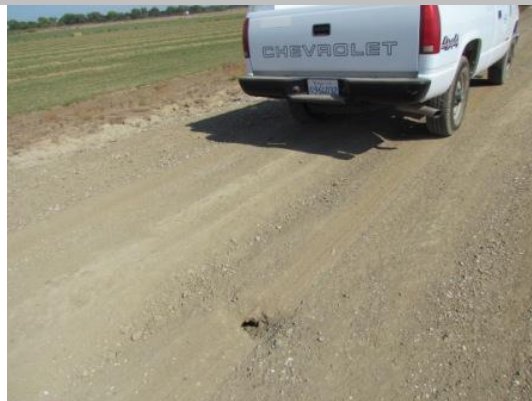
Photo 2 of 3 : FA_2014_RD2101_326_18_20141001_00011.jpg

View of the rodent hole in the levee crown. Smaller holes were covered due to crown regrading. 09/25/2012

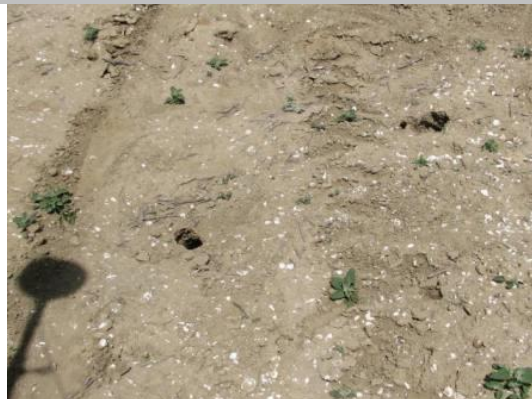
Photo 3 of 3 : FA_2014_RD2101_326_18_20141001_00012.jpg

LM Start	3.11	Rating **	M	Issue No.	18 (cont)	
LM End	3.11	Issue Type +	Ma	Location *	CR	
Category	Earthen Levee			GPS Latitude/Longitude		
				Start	End	
Item	Animal Control			37.637943 °	37.637943 °	
				-121.232620 °	-121.232620 °	
DWR ID	DWR_RD2101_01_s_2012_18					
Action/Comments						
No rodents visible, but rodent burrows visible; need to backfill and compact or grout burrows. Inspector Comments: Large burrow in crown with no rodents present at time of inspection.

05/02/2012 Rodent holes in the levee crown.
